# CASE STUDY

## Biloxi Pedestrian Beach Pathway

Helical Piles Support Boardwalk / Prevent Beach Erosion

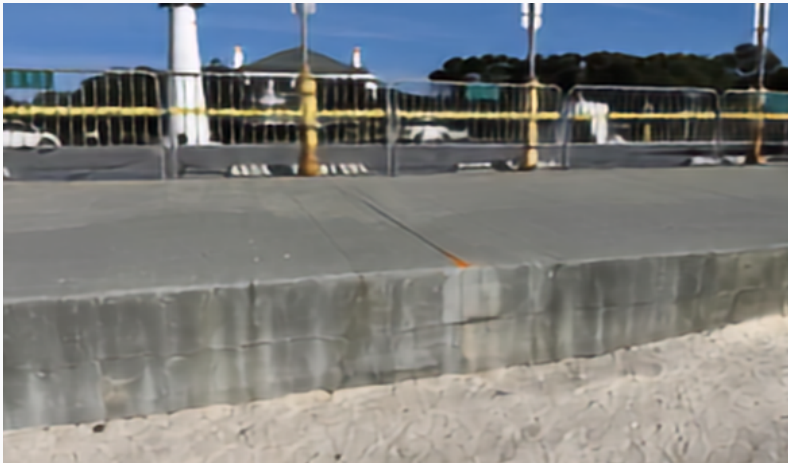
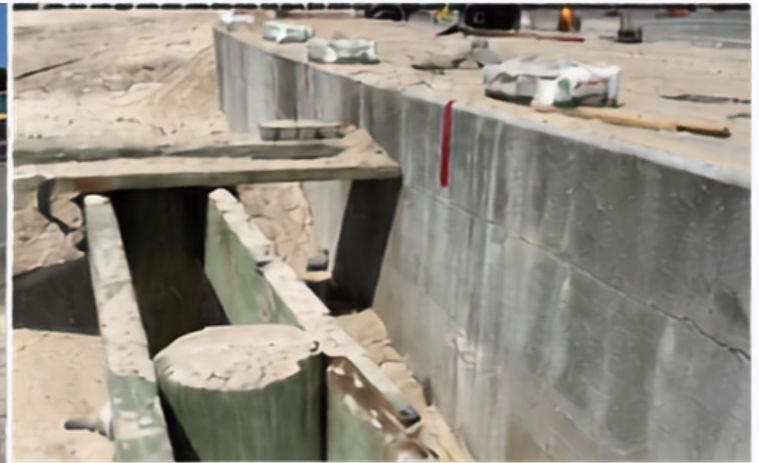
Continued storm activity and storm surge over time damaged the concrete pedestrian walkway located on the beach in Biloxi, MS. The result was erosion of the beach that compromised the foundation wall intended to support the 12' + wide pedestrian walkway at the connection where it intersected with the wood boardwalk that extended into the ocean. The destruction affected an area of the boardwalk stretching roughly 200 feet in length with maximum settlement of 14" at worst, leaving the boardwalk in an unsafe condition for pedestrian use.

12° diameter core holes confirmed that storm surge had eroded most of the fill material (sand) beneath the walkway. The scope also included placing an estimated 250 CY of sand and 50 CY of flowable fill beneath the walkway following the lift.

Cantsink was retained by a consulting engineer on behalf of the Harrison County Engineering Department to evaluate and repair the damage. Following a site visit, the team determined the most effective solution was to underpin the face side of the wall and lift the 200 LF section evenly across all brackets, beginning at the 14° low point and tapering to about 0.5° where the structure met undamaged sections.

Lifting was performed in progressive increments to limit cracking of the footings and walls and to avoid binding of the wall and footing system. Elevations were recorded before, during, and after the lift. The structure was raised the full 14° of settlement, achieving a slight pitch away from the beach and back toward the parking area as intended, and fill material was placed beneath the walkway following the lift.
