Case Study

# ST. AUGUSTINE, FL, POOL DECK UNDERPINNING DURING HOME RENOVATION

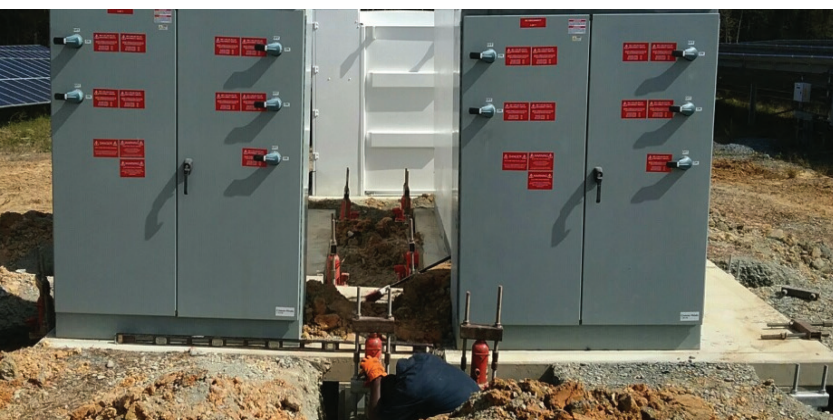
The Contractor noticed the pads had experienced settlement within the first year that ranged from 1" to 3.5", except for one inverter pad which showed no signs of settlement.

The pads are set in place with the assistance of a lift, or crane, depending upon the actual loads. The wiring is extended through pre-cut openings for connection to the equipment. Photo 1 below illustrates the pad condition at one of the locations – typical of others.

The repair work consisted of installing Cantsink Helical Piles with remedial underpinning brackets to stabilize and lift the settled concrete pads to an original level state.
