# CASE STUDY

## Biloxi Pedestrian Beach Pathway

Helical Piles Support Boardwalk / Prevent Beach Erosion

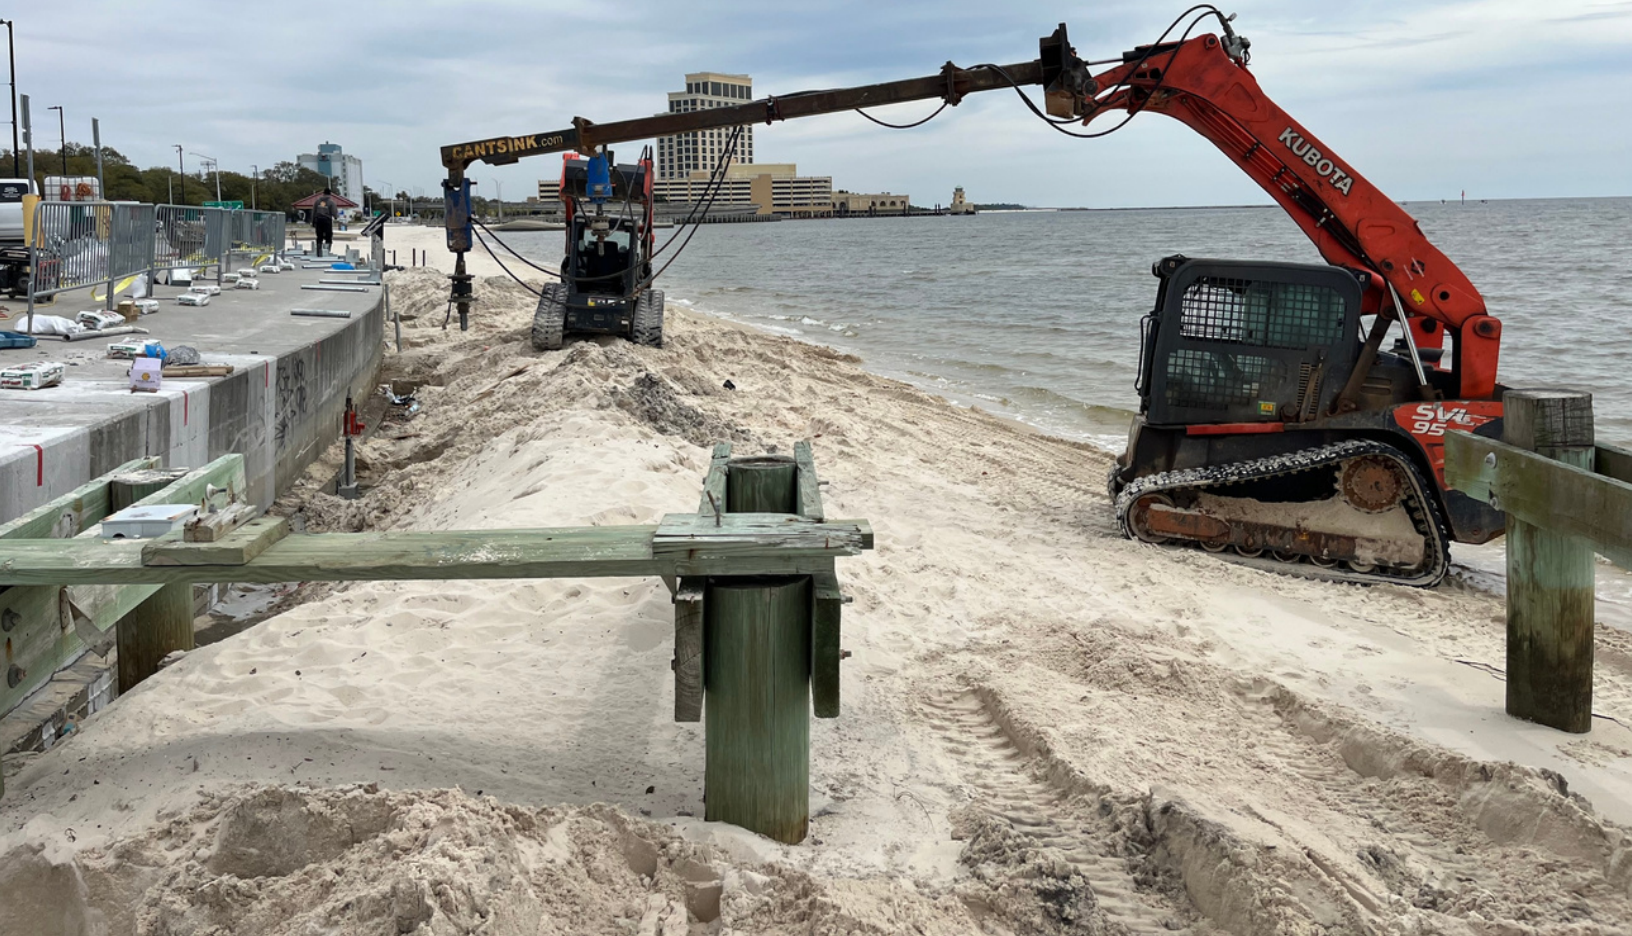
Continued storm activity and storm surge over time damaged the concrete pedestrian walkway located on the beach in Biloxi, MS. The result was erosion of the beach that compromised the foundation wall intended to support the 12' + wide pedestrian walkway at the connection where it intersected with the wood boardwalk that extended into the ocean. The destruction affected an area of the boardwalk stretching roughly 200 feet in length with maximum settlement of 14" at worst, leaving the boardwalk in an unsafe condition for pedestrian use.

Cantsink was retained by a consulting engineer on behalf of the Harrison County Engineering Department to evaluate and repair the damage. Following a site visit, the team determined the most effective solution was to underpin the face side of the wall and lift the 200 LF section evenly across all brackets, beginning at the 14° low point and tapering to about 0.5° where the structure met undamaged sections.

Lifting was performed in progressive increments to limit cracking of the footings and walls and to avoid binding of the wall and footing system. Elevations were recorded before, during, and after the lift. The structure was raised the full 14° of settlement, achieving a slight pitch away from the beach and back toward the parking area as intended, and fill material was placed beneath the walkway following the lift.
