## CASE STUDY DELAND, FL

### TOWNHOME REMEDIAL UNDERPINNING STABILIZING A SHIFTIN FOUNDATION

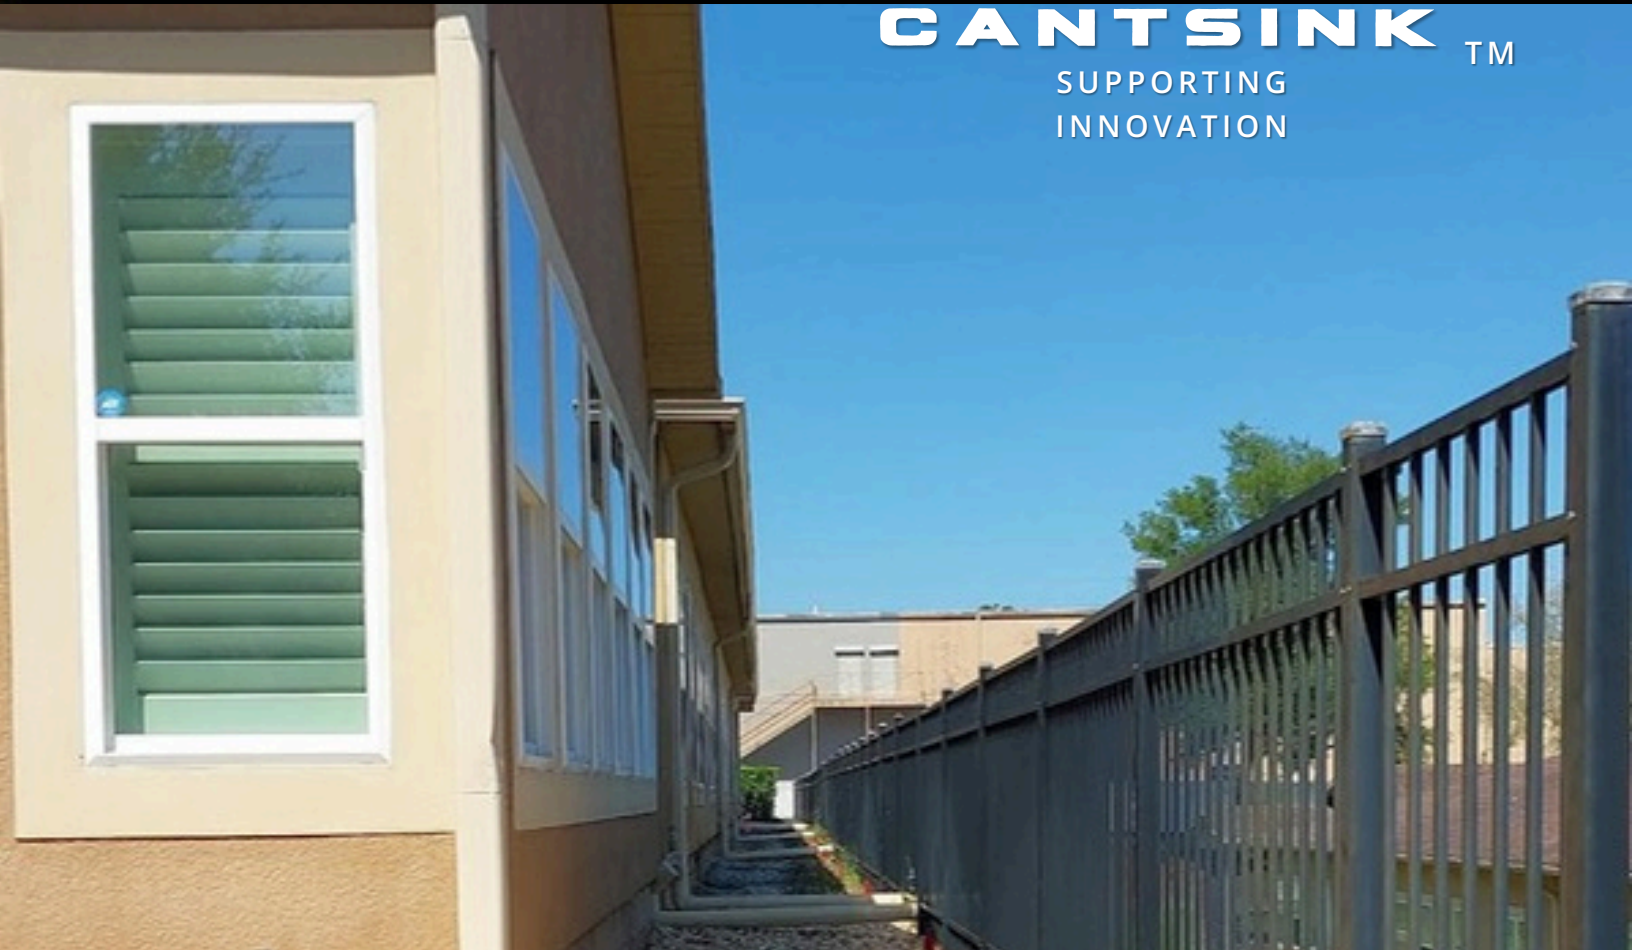
A townhome structure in DeLand, Florida began showing troublesome signs of shifting foundations, to the point that the owners contacted Cantsink representatives for professional advice. The movement appears to be the product of shifting soils caused by years of erosion, which left the existing shallow footing without consistent support. The recommended solution was remedial underpinning: installing helical piles that carry the structure's load past the weakened surface soils and onto deeper, stable bearing strata. Site access was a major constraint. The rear of the townhomes offered very limited working space, and earlier land leveling and de-mucking of the soil had created a drop-off that required a retaining wall to keep the soil stable. The piles closest to that wall had to be installed in extremely tight conditions.

CANTSINK LLC WAS CONTRACTED TO INSTALL HELICAL PILES AS REMEDIAL UNDERPINNING ALONG THE REAR OF THE TOWNHOMES, STABILIZING THE EXTERIOR FOOTING. A TOTAL OF 29 PILES WERE INSTALLED, TOTALING APPROXIMATELY 522 LINEAR FEET, INCLUDING THOSE IN THE AREA CLOSEST TO THE RETAINING WALL, WHERE VERY LIMITED SPACE REQUIRED SPECIALIZED EQUIPMENT SIZED FOR THE CONFINED WORKING AREA.
