Termite, Pest and Rodent Inspection Report

Inspection Date:	Dec 7, 2025
Client Name:	John Doe
Client Email:	mickey.spillane@pestnation.com
Client Phone Number:	8178456741
Agent Email:	samuelo.bombiza@pestnation.com
Address (street):	123 S Willow CT
Address (City, State, Zip):	Cumming GA 30212
Structure Type:	Single Family Dwelling- Slab
Year Built:	2006
Square Footage:	1870
Lot Size:	0-.25 Acres

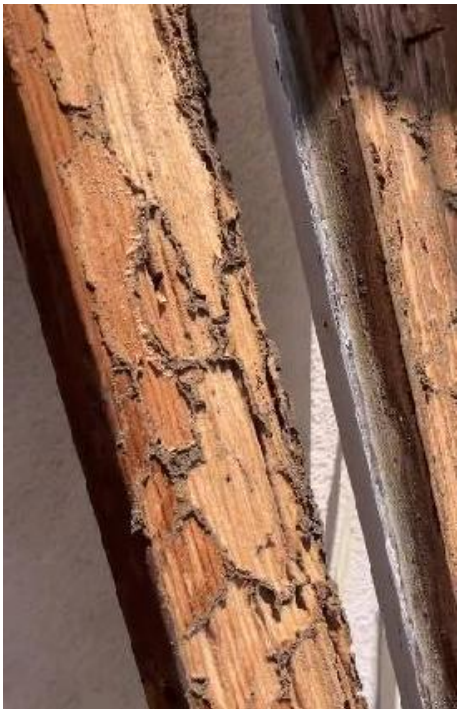
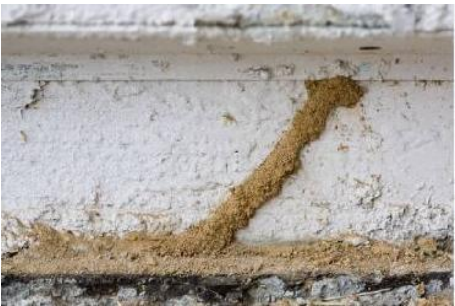
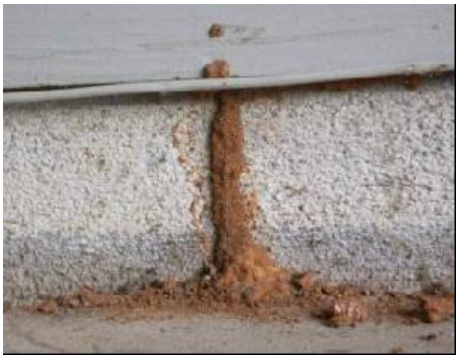
Termite Images:

Active termite activity found at time of inspection.

Exterior siding and garage

Siding less than 6 inches from grade
AC lines dripping water next to foundation-- Needs to be extended four feet

Termite Image Notes:	During the inspection, we found active termite activity in the exterior siding and garage door of the home.
Termite Treatment Recommended:	Yes, treatment is recommended due to signs of termites.
Type of Treatment Recommended:	Sentricon with Liquid Spot Treatment
Sentricon System Fee:	\$999.00
Annual Renewal Fee:	\$350.00
Type of Warranty Provided:	Retreat Warranty

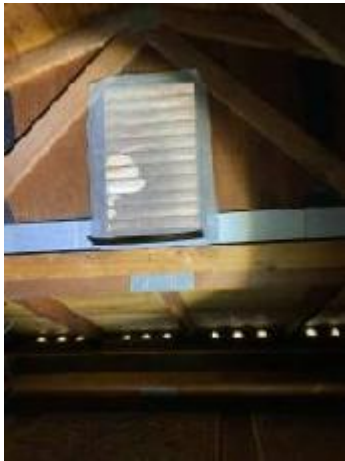
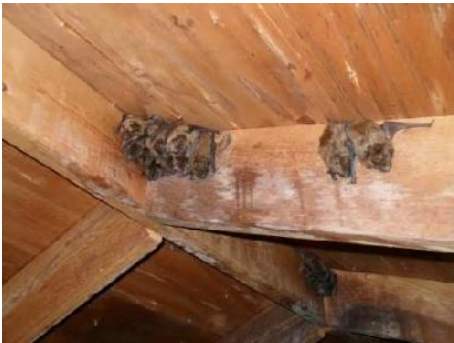
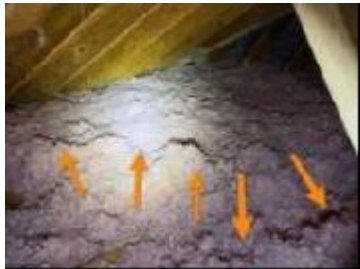
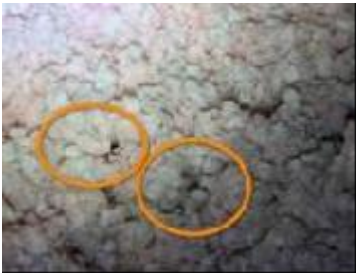
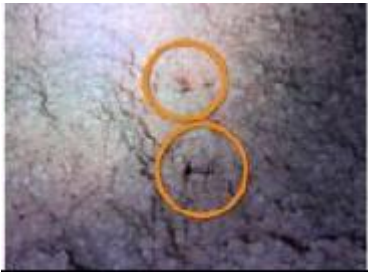
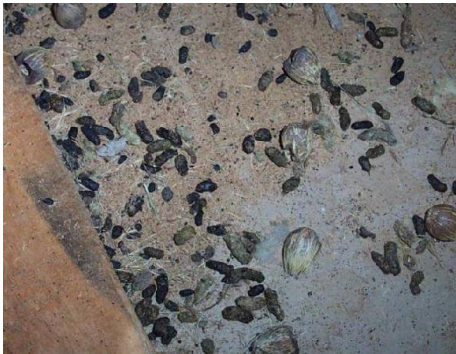
Rodent Images:

General Rodent Findings:	Roof Rats Bats Flying Squirrels
Location of Rodent Findings:	Attic
Approximate Linear Footage:	215

During the inspection, we found live bats in the attic, along with rodent droppings consistent with roof rats and flying squirrels. We also observed that the gable vent screen is damaged, which can create accessible entry points for rodents and other wildlife, increasing the likelihood of active or future infestations.

We recommend a full exclusion service, which involves sealing all current and potential entry points throughout the structure to prevent bats, rodents, and other wildlife from entering or re-entering the property. This is the most effective long-term solution to resolve the existing activity and protect the home moving forward. Please see the pricing below.

Wildlife Service Recommended:	Yes, visible signs of rodent/wildlife activity found during the inspection.
Type of Wildlife Service Recommended:	Complete Exclusion Trapping Rodent Bait Boxes
Wildlife Exclusion Initial Fee:	\$2,300.00
Exclusion Renewal Fee:	\$230.00
Rodent Bait Box Initial Fee:	\$250.00
Rodent Bait Box Monthly Fee:	\$50.00

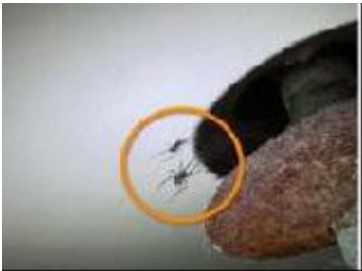
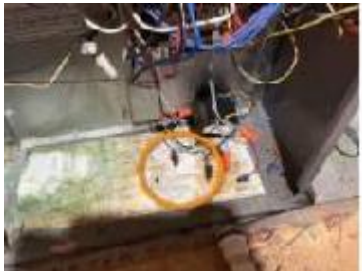
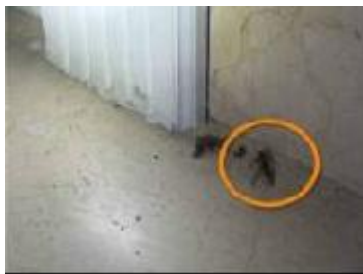
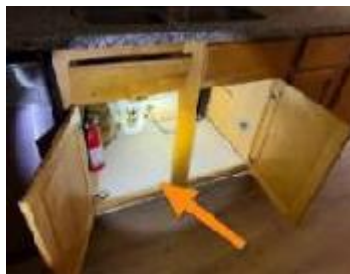
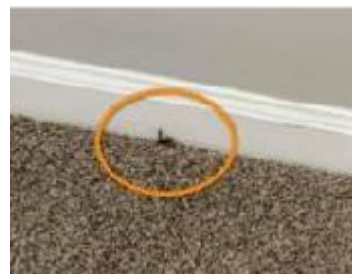
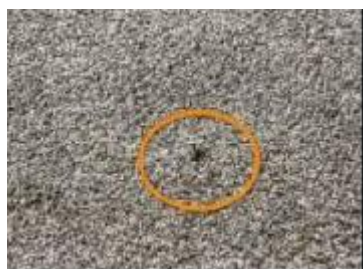
Pest Images:

General Pest Findings:	General Household Pests
Location of Pest Findings:	Interior Exterior

During the inspection, we found general pest activity, evidence of roaches, potential roaches or cricket droppings, carpenter bee damage to wood and wasps at the home. We recommend pest control

Carpenter bee treatment \$250
